Tomczyk, A.M. and Ewertowski, M. (2013) 'Quantifying short-term surface changes on recreational trails : the use of topographic surveys and 'digital elevation models of differences' (DODs).', *Geomorphology*, 183 . pp. 58-72.

## **Quantifying Short-Term Surface Changes on Recreational Trails: The Use of Topographic Surveys and ‘Digital Elevation Models of Differences’ (DODs)**

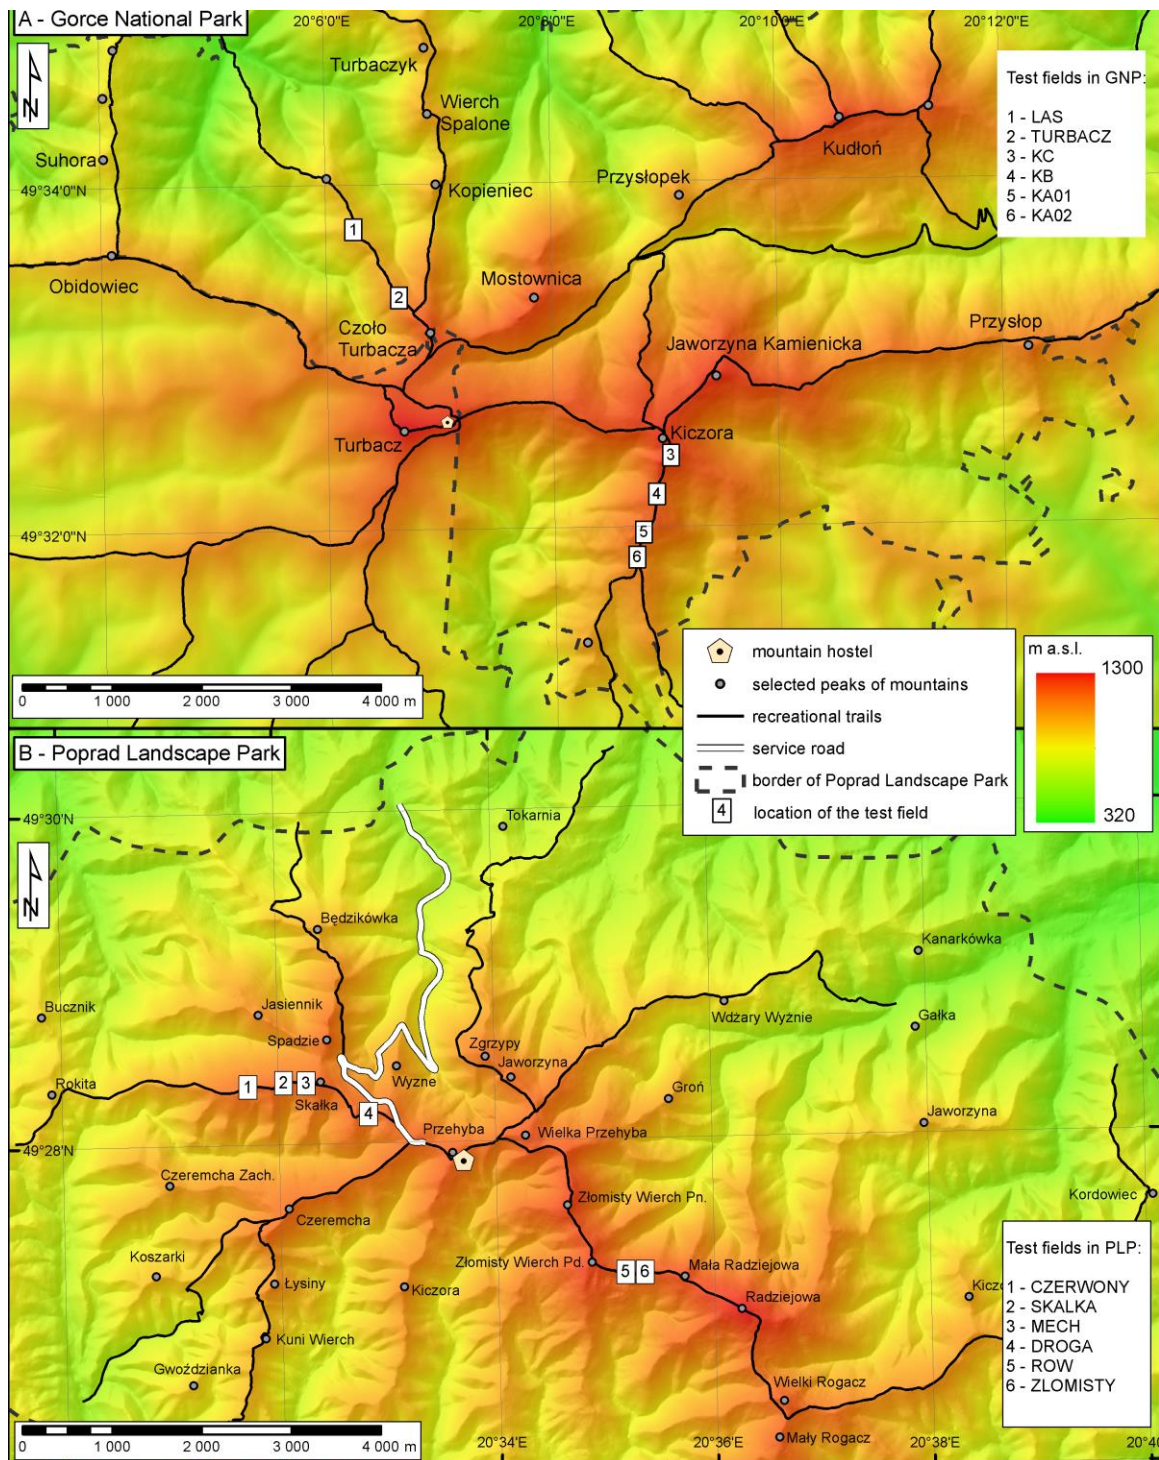
Fig. 2. Location of the test fields. A - Gorce National Park, Poland; B – Poprad Landscape Park, Poland.

Six test fields were installed on the trails in the GNP (Fig. 2A; Table 1), and the other six within the Radziejowa Range in the PLP (Fig. 2B, Table 1). We were not able to calculate precisely the number of visitors for each trail; however, we managed to qualitatively determine the amount of use from interviewing experienced park managers. This was done in a way similar to Olive and Marion (2009) and Wimpey and Marion (2010). All the test fields receive a similar amount of use. Based on field surveys and park managers' experience, we can estimate the daily number of visitors during high season (from the end of June to the end of August). This number varied from 10 to 140 people per day. The maximum number of visitors is usually seen during weekends (Friday to Sunday). The type of use observed on the test fields also varied. Five of them are used only by hikers, six by hikers and cyclists, and one is used also as a forest road for motorized vehicles. The mean slope of trail tread (trail grade) varied from 6 to 23°. Trails mainly follow ridges, after climbing from valleys, however different aspects of trail tread and local morphological settings were also taken into account. The altitude was generally between 1,100 and 1,250 m a.s.l. Six of the test fields are located on meadows (glades) covered by European Blueberry (*vaccinium myrtillus*) communities (sometimes with the addition of spruce - *pices abies* - secondary communities). The other six are

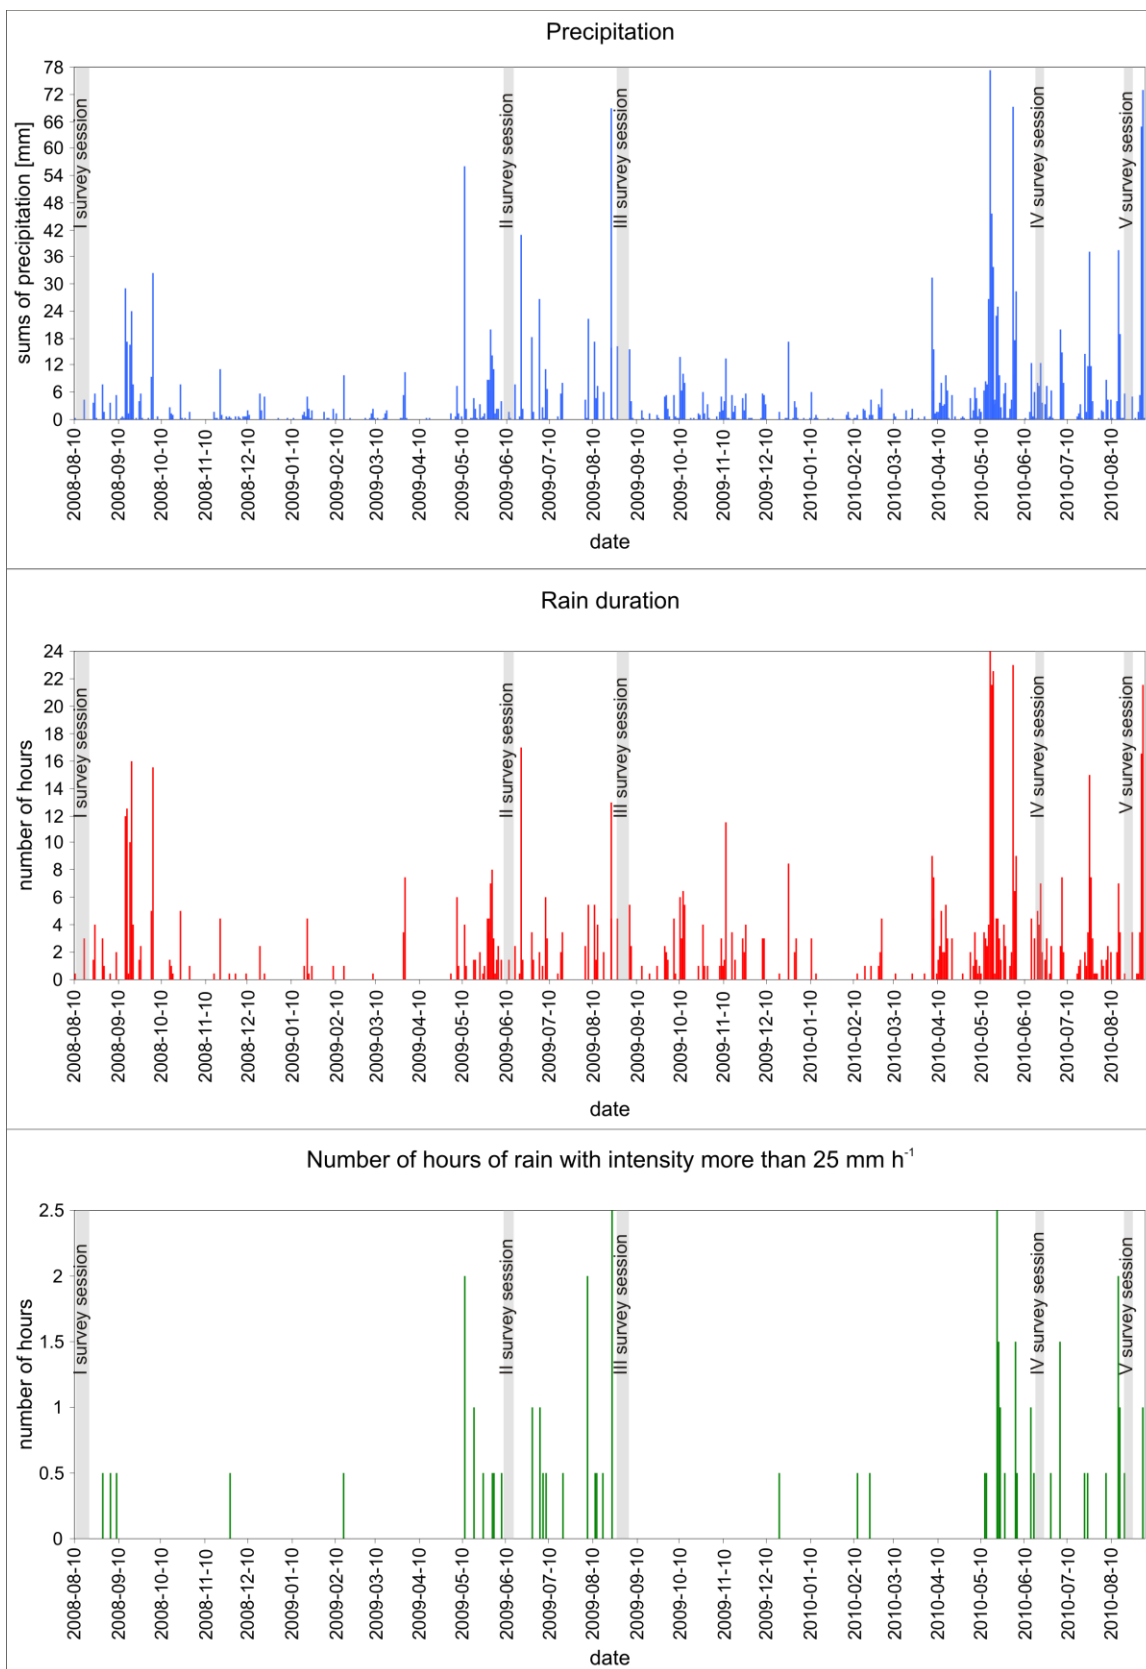
Fig. 3. Sums of precipitation, rain duration, and intensity of 25 mm h<sup>-1</sup> of rain. Survey dates are marked in grey (data from the meteorological station at Suhora)

Five measurement sessions were carried out for each test field: August/September 2008, June 2009, August/September 2009, June 2010, August/September 2010. Photographic monitoring was also carried out at these dates. Figure 3 presents data on precipitation, together with the timing of test field surveys.

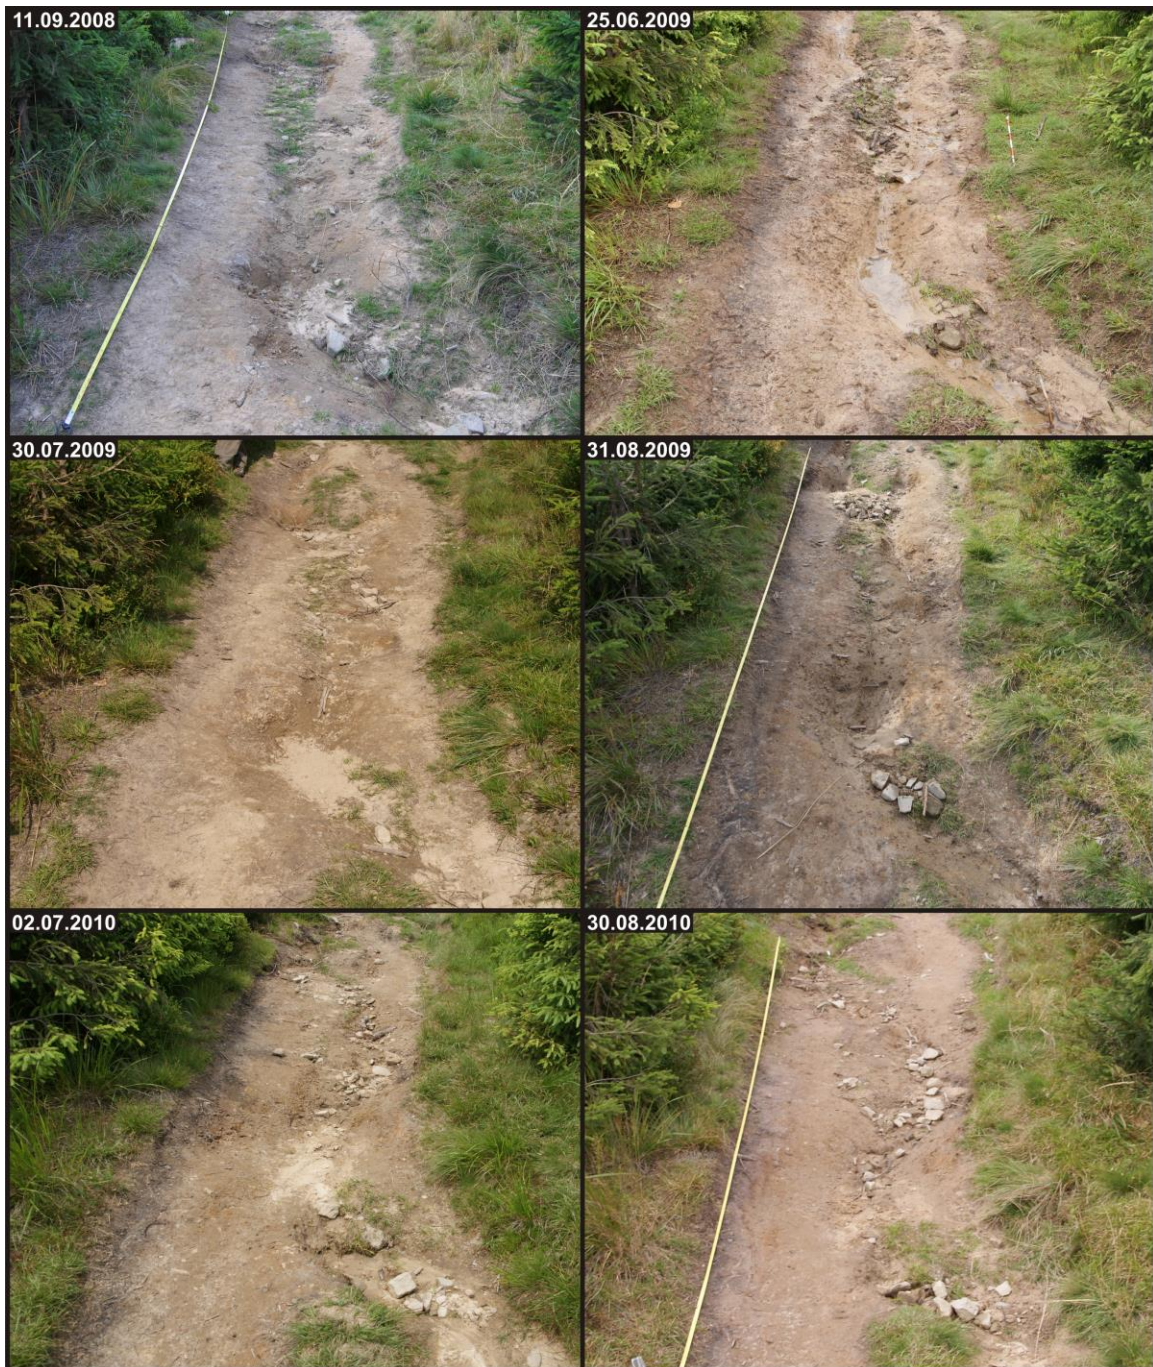
Fig. 4. The state of the trail and its surroundings for the selected dates – test field (P)ZLOMISTY. Notice the small plunge pools filled in with material and subsequently eroded

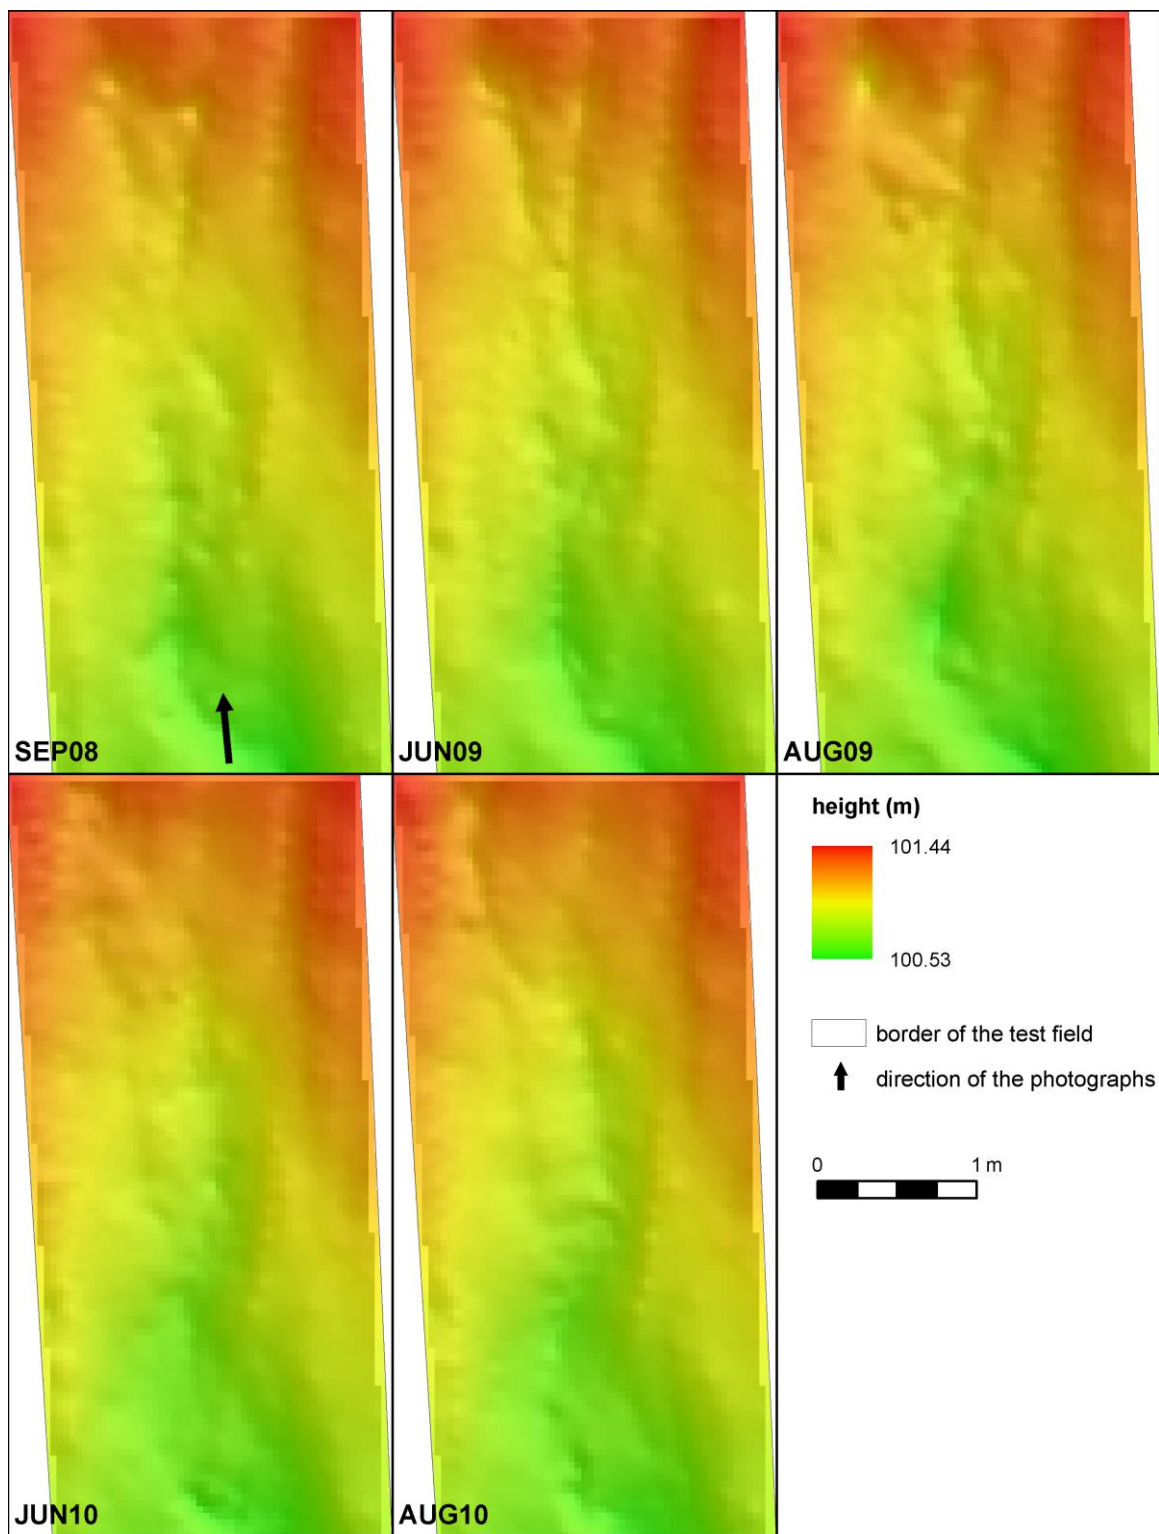
Fig. 5. Digital elevation models of the test field (P)ZLOMISTY

A total of five digital elevation models (DEMs) using inverse distance interpolation methods and cell size 1 x 1 cm were created for each test field. Checkpoints, which were not used when creating the models, were used to assess the accuracy of the DEMs. The root mean square error (RMSE) for each set of checkpoints was used to measure the accuracy of mapping relief within each model. The RMSE for the DEMs was less than 1 cm.

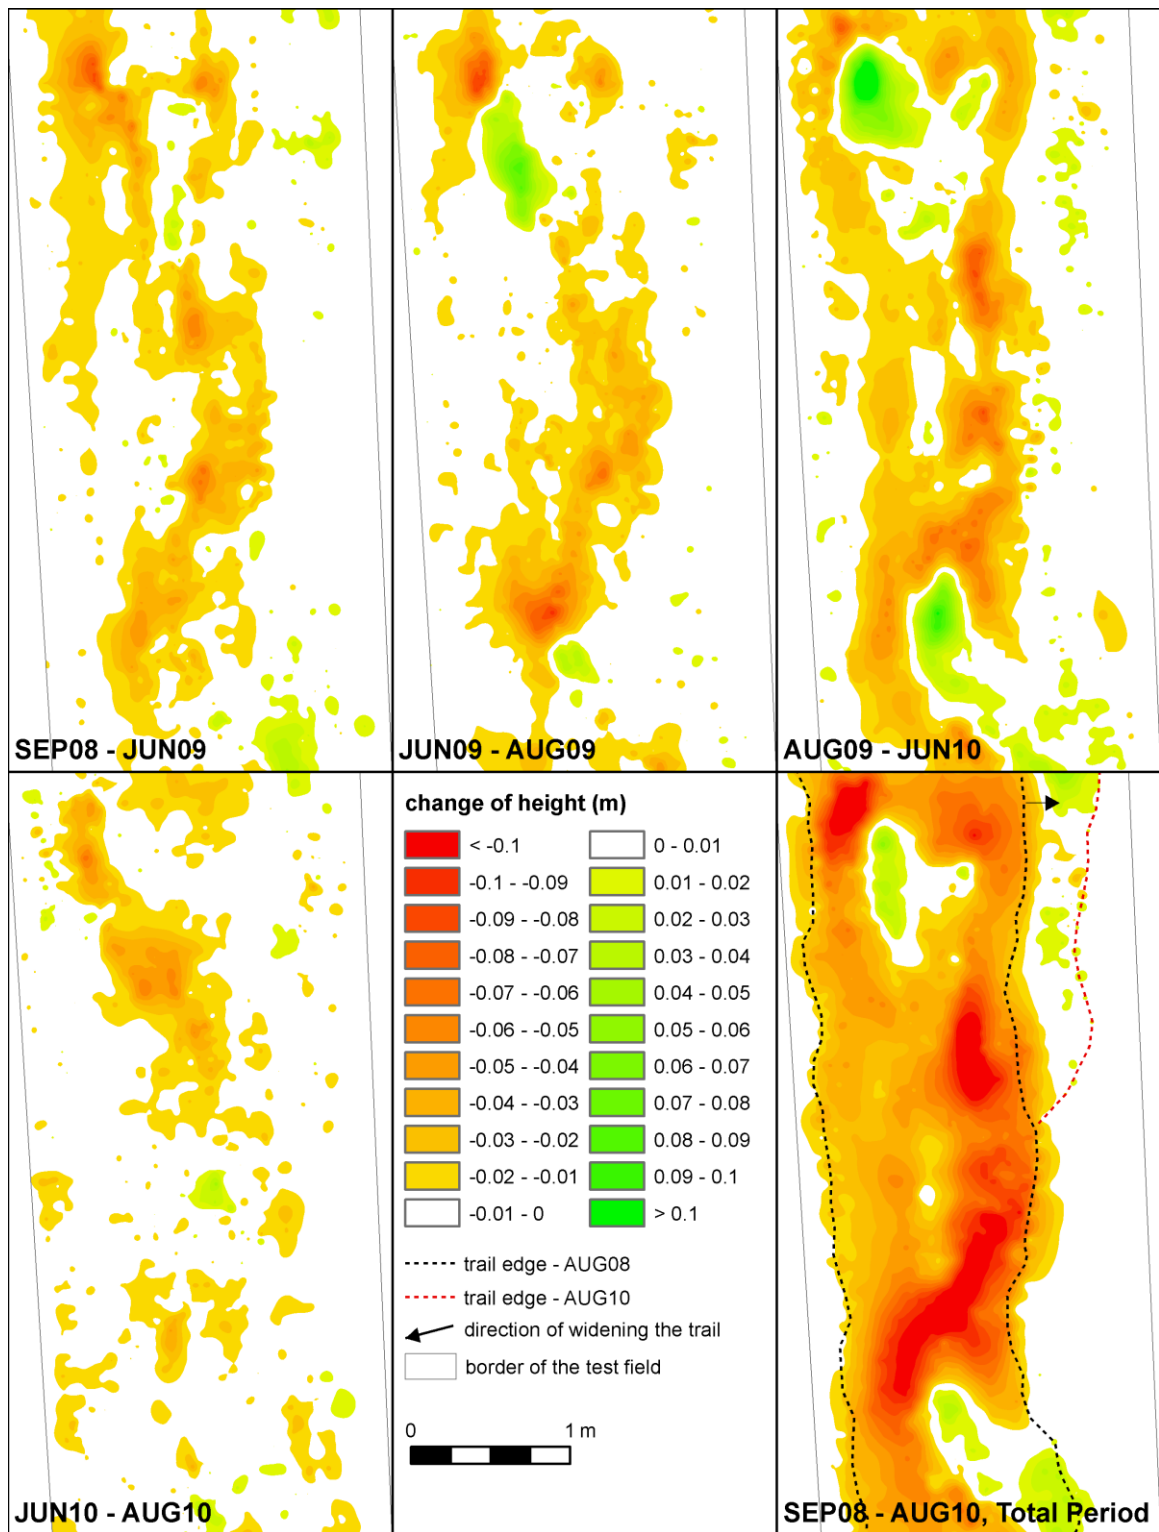
Fig. 6. DEMs of Differences (DODs) showing the spatial distribution of surface transformations – test field (P)ZLOMISTY

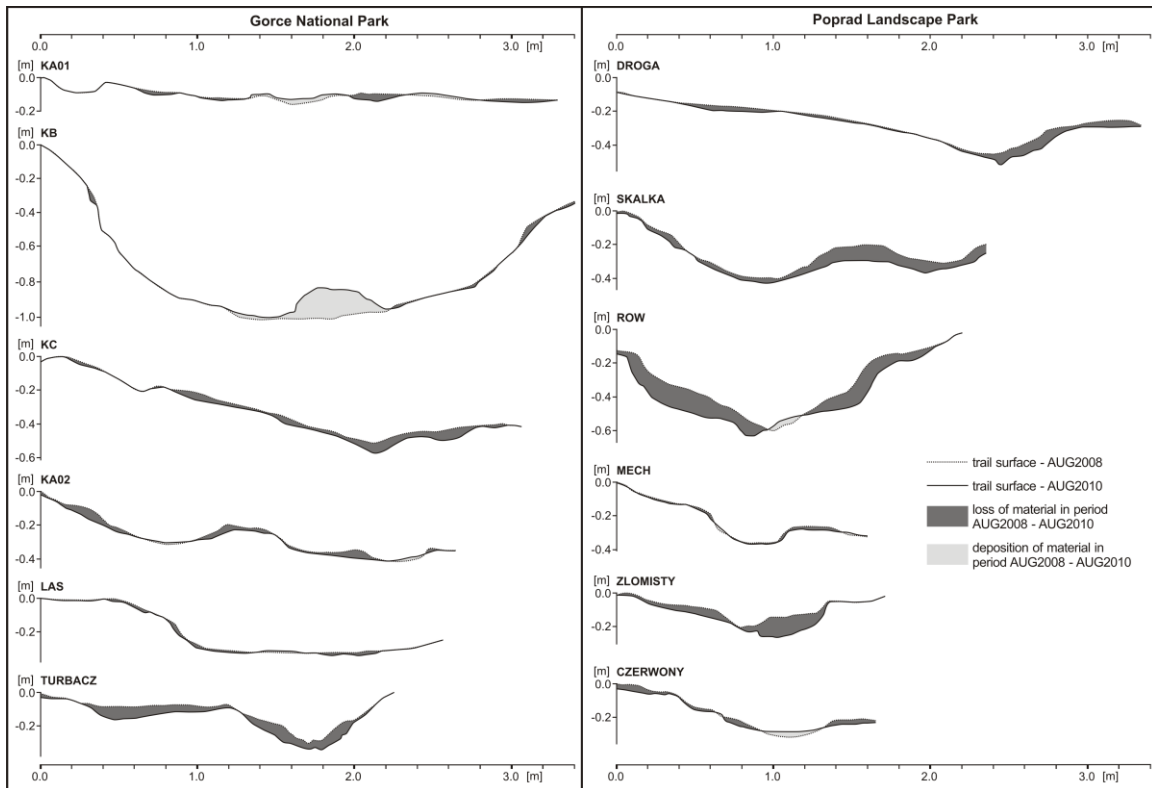
Fig. 7. Examples of elevation profiles perpendicular to the trail tread. Changes in elevation between August/September 2008 and August/September 2010 are marked in dark (soil loss) or light grey (deposition)

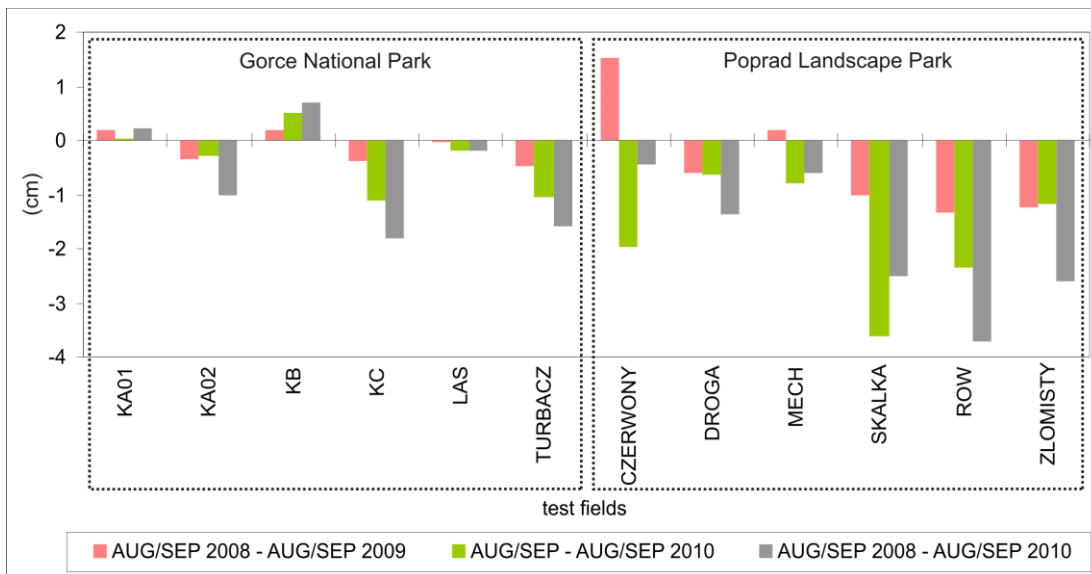
Fig. 8. Mean changes in surface elevation in test fields located in the GNP and PLP

The transformation of the trail surface within the test field occurred unevenly in time and space. The average annual change in elevation between August/September 2008 and August/September 2010 ranged from -3.7 cm for a test field (P)ROW to +0.7 cm for fields (G)KB (Fig. 8). One can distinguish the fields in which the magnitude of change in two consecutive years was similar (e.g. (P)ZLOMISTY, (P)DROGA, (G)KA02) and those where the magnitude of change in the second year far exceeded the transformations observed between August/September 2008 and August/September 2009 (e.g. (P)ROW,

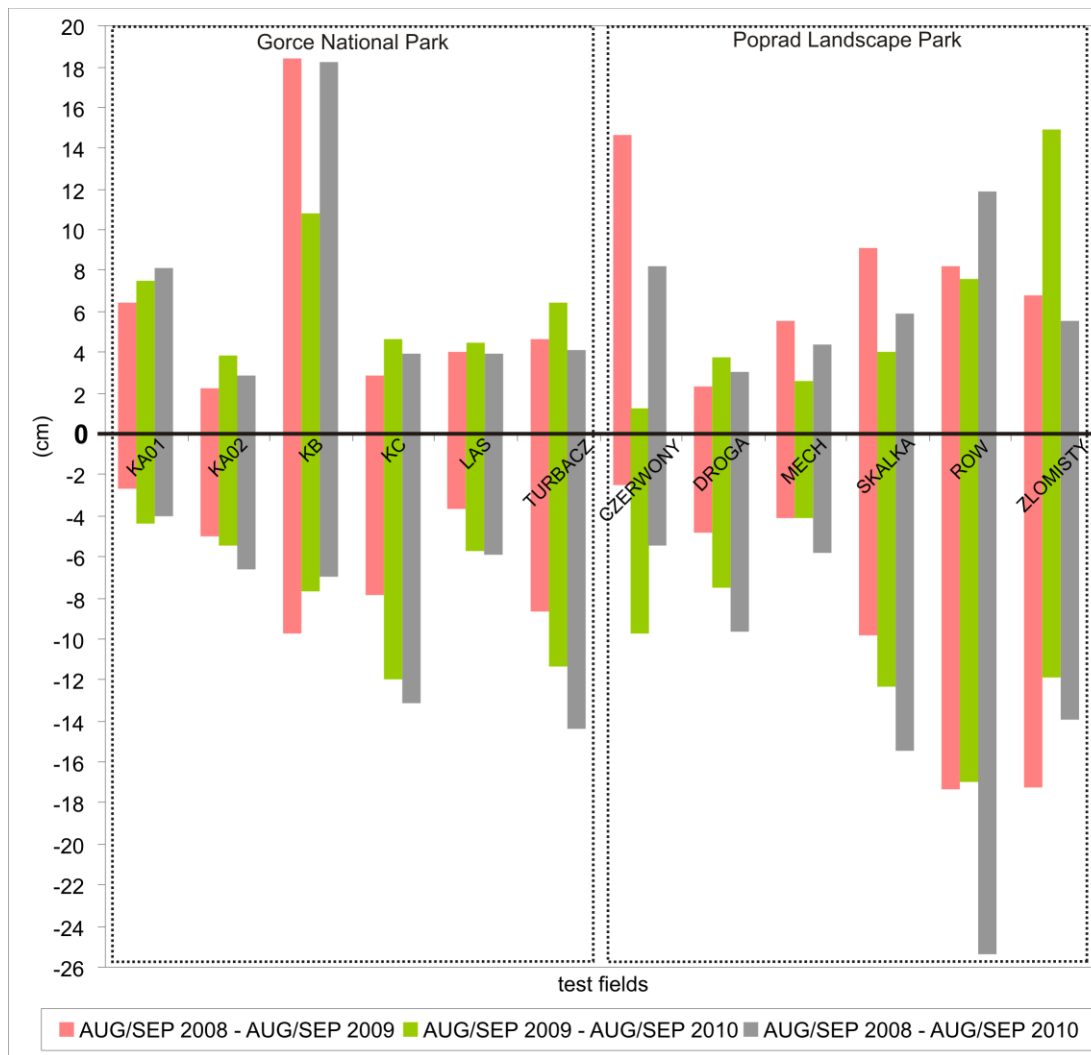
Fig. 9. Local maximum changes (lowering and raising) in the elevation of the recreational trails' surface in test fields located in the GNP and PLP

Within two years, the maximum amount of local reduction of trail tread surfaces within the test field ranged from -25 cm for the field test (P)ROW to -4 cm for the test field (G)KA01 (Fig. 9). However, next to the places where there was a substantial soil loss, parts with deposition of material were observed. The maximum values of local deposition within a two-year period ranged from 3 cm for (G)KA02 and (P)DROGA to 18 cm for the test fields (G)KB.

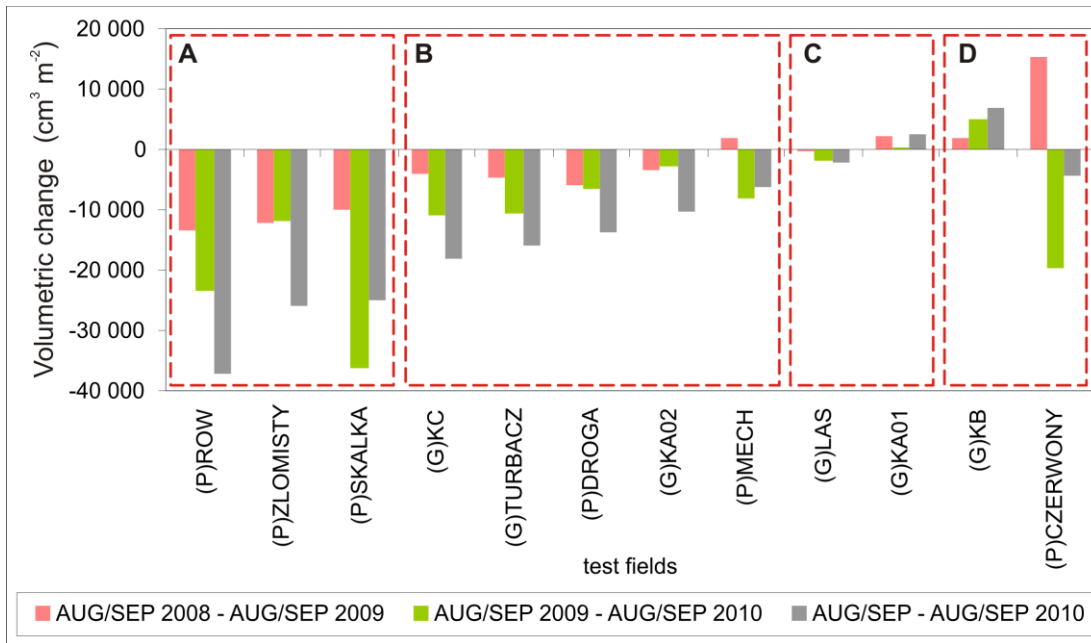
Fig. 10. The average change in the volume of soil per 1 m<sup>2</sup> within the test fields located on recreational trails of the GNP and PLP. Groups of the test fields are marked by capital letters as follow: A - Test fields with a substantial soil loss; B - Test fields with a moderate soil loss; C – Test fields with low relief transformation; D – Test fields on which unusual phenomena occurred.

On the test fields (G)KC, (G)TURBACZ, (P)DROGA, (G)KA02, (P)MECH, erosion was considerably greater than deposition, and the volume of soil loss for four of them ranged from 10,000 cm<sup>3</sup> m<sup>-2</sup> to 20,000 cm<sup>3</sup> m<sup>-2</sup>. On the fields (G)KC and (G)TURBACZ, soil loss in the second year of measurement (August/September 2009 - August/September 2010) was significantly greater than a year earlier. On the fields (P)DROGA and (G)KA02, the volumes of soil loss in both years were similar. Somewhat different surface modifications were observed for the test field (P)MECH: in the first year of measuring, a small amount of deposition was recorded, while in another, a distinct soil loss happened. The factors influencing the prevalence of soil loss within these fields are the following:

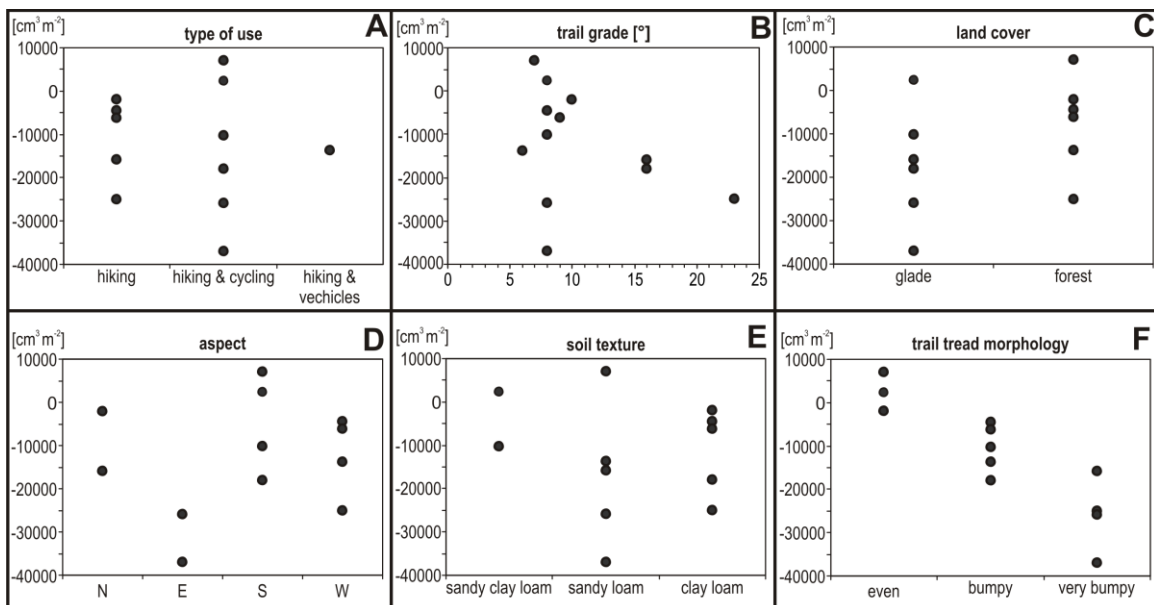
Fig. 11. Relationship between changes in the volume of soil in the period August/September 2008 to August/September 2010 and selected managerial and environmental factors

For the studied test fields there is no observable relationship between the type of use and amount of soil erosion (Fig. 11A). However, the type of use has mainly influenced the way in which direct human impact occurs on trails. Hikers trampled on vegetation and caused soil compaction, especially in flat segments of trail tread. However, in muddy conditions (especially in soils containing lots of clay) or for uneven trail tread containing many sharp microforms, hikers' boots can slide and relocate soil particles. Moreover, trekking sticks contribute to loosening of the soil, and in this way also prepare material to be transported. The influence of bikers is slightly different. Tyres generate higher pressure on the soil than boots, and often, especially on steep sections, cause soil to loosen and relocate. It suggests that park managers can effectively control soil loss by choosing the appropriate type of use rather than limiting the number of visitors.

In our opinion, soil properties (Fig. 11E) (cf. McHugh, 2007), morphology of the trails (Fig. 11F) (cf. Bryan, 1977; Cakir, 2005) and local geomorphological conditions (especially slope length above the test field) are factors which have the greatest influence on the amount of soil loss. These three factors are often linked together. The examined sections of the trails, whose surfaces are overgrown by tree roots - (P)CZERWONY - or are covered with numerous rock fragments - (G)LAS, (G)KB - show the least transformation. Roots act as sediment traps and cause the deposition of fine grained material. Similarly, rocks can also protect the soil against excessive water erosion. When the trail tread is even, the pressure of hikers' boots causes soil compaction, which makes water erosion difficult. An uneven trail tread can affect trail development in two ways. First, when the trail is hard to walk on, visitors start to bypass the deteriorated section which leads to trail widening. Moreover, a rough trail tread also favours significant soil erosion - (P)SKALKA, (P)ROW, (P)ZLOMISTY. For an uneven tread, hikers destroy microforms and cause soil to loosen, and in such a way facilitate water erosion and transport. Accelerated soil erosion is also facilitated by location in the bottom part of the local slope - (P)ZLOMISTY, (P)ROW. In such cases, the volume of flowing water after rain is high, which provides greater erosional and transportational power. The effect of

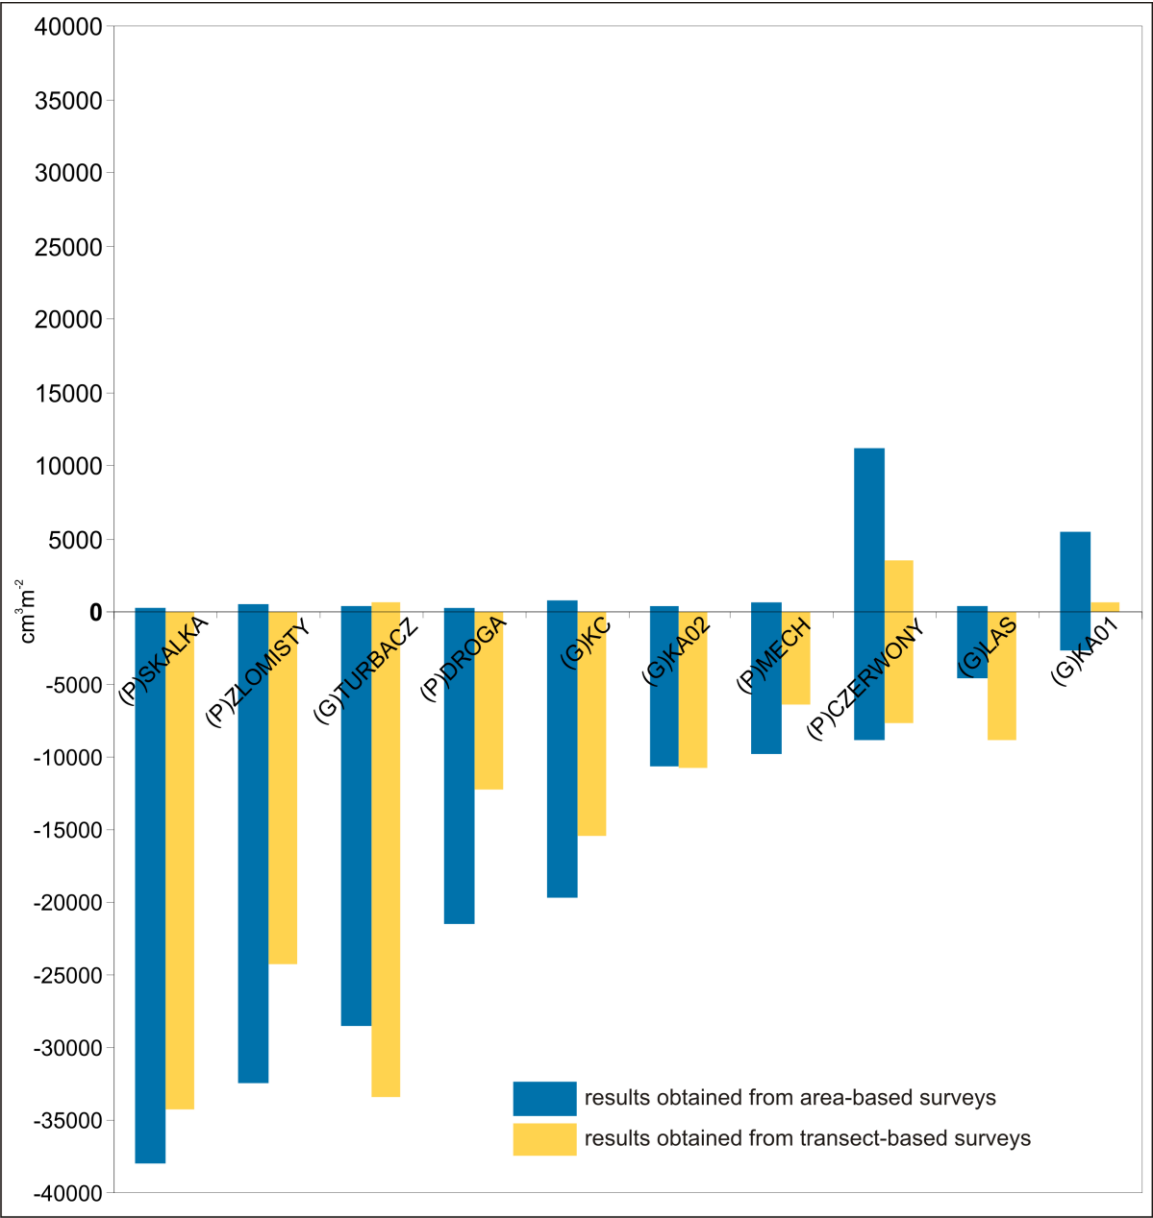
Fig. 12. Comparison of the volumes of soil loss/deposition calculated from transect- and area-based measurements.

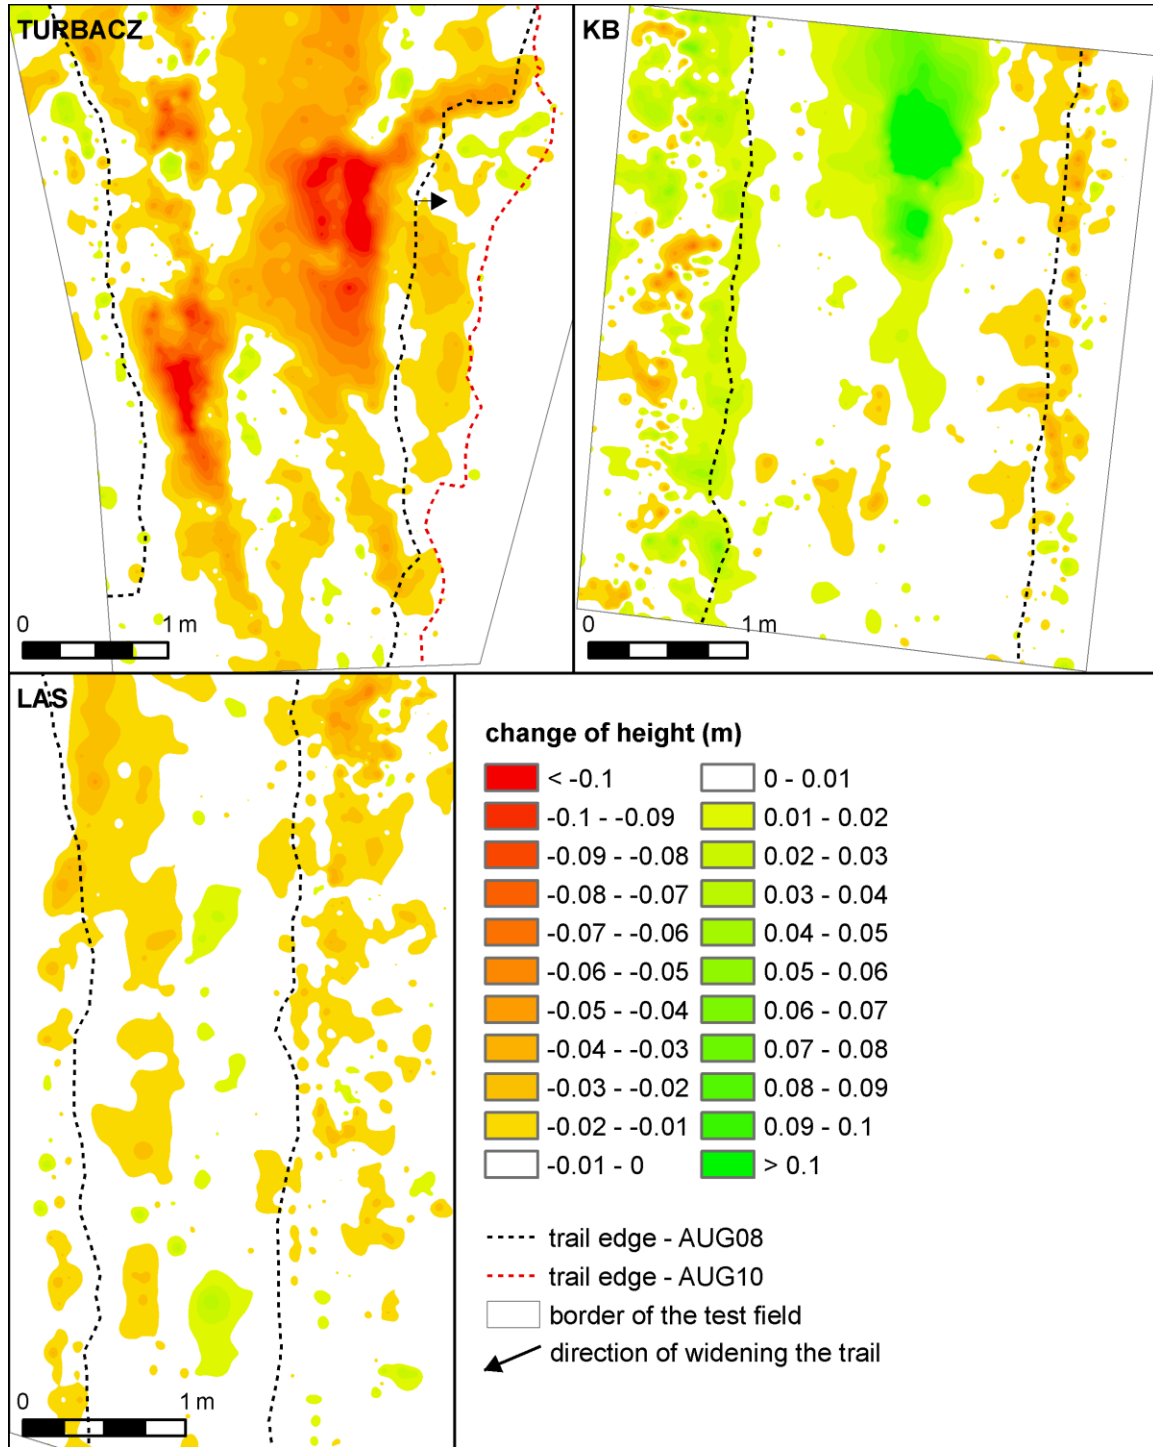
Figure A-1. DEMs of Differences (DODs) showing the spatial distribution of surface transformations between August/September 2008 and August/September 2010 – test fields located in the GNP – Part I.

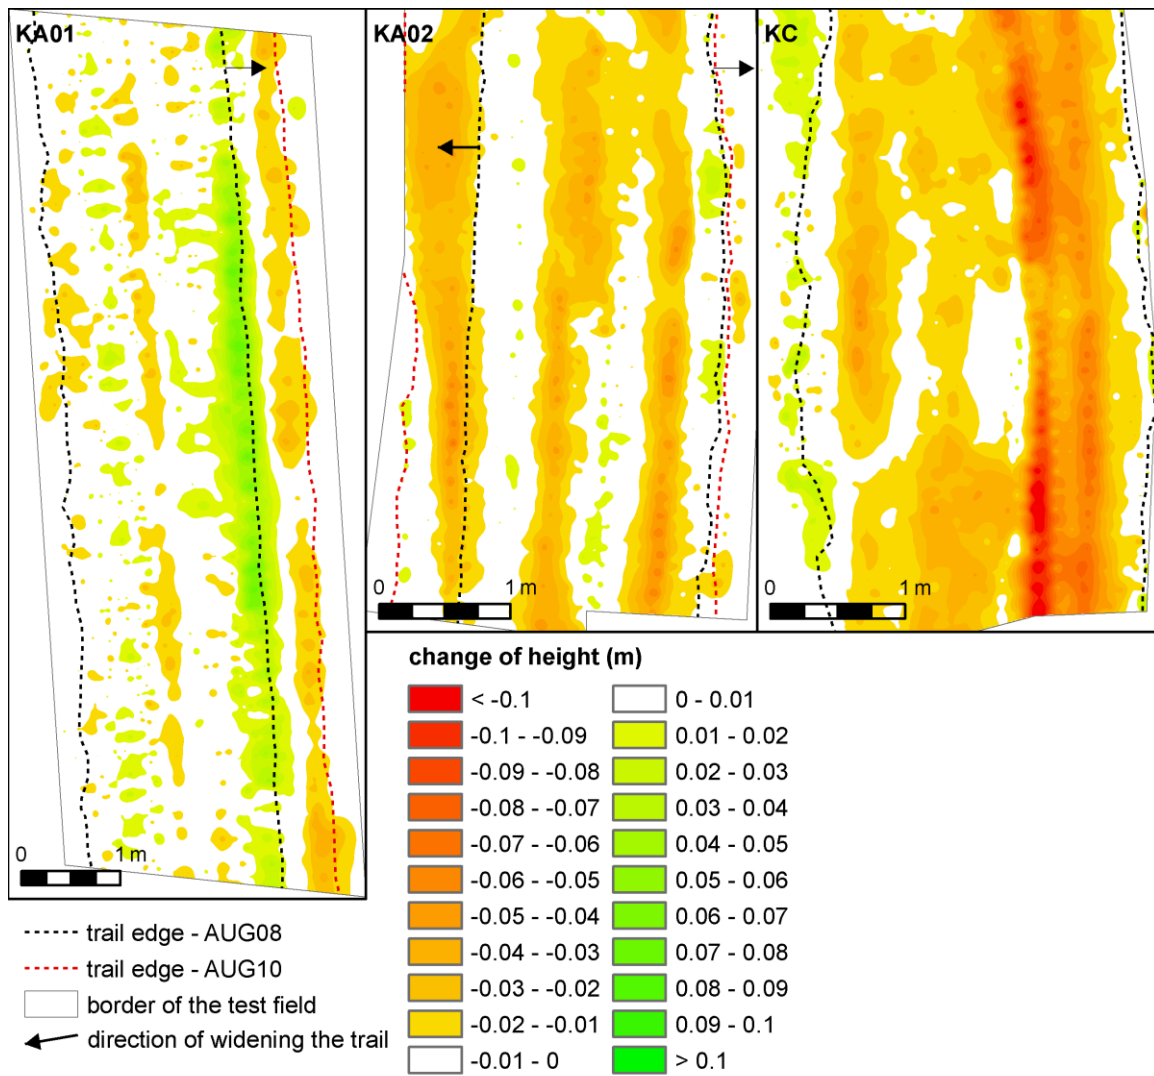
Figure A-2. DEMs of Differences (DODs) showing the spatial distribution of surface transformations between August/September 2008 and August/September 2010 – test fields located in the GNP – Part II.

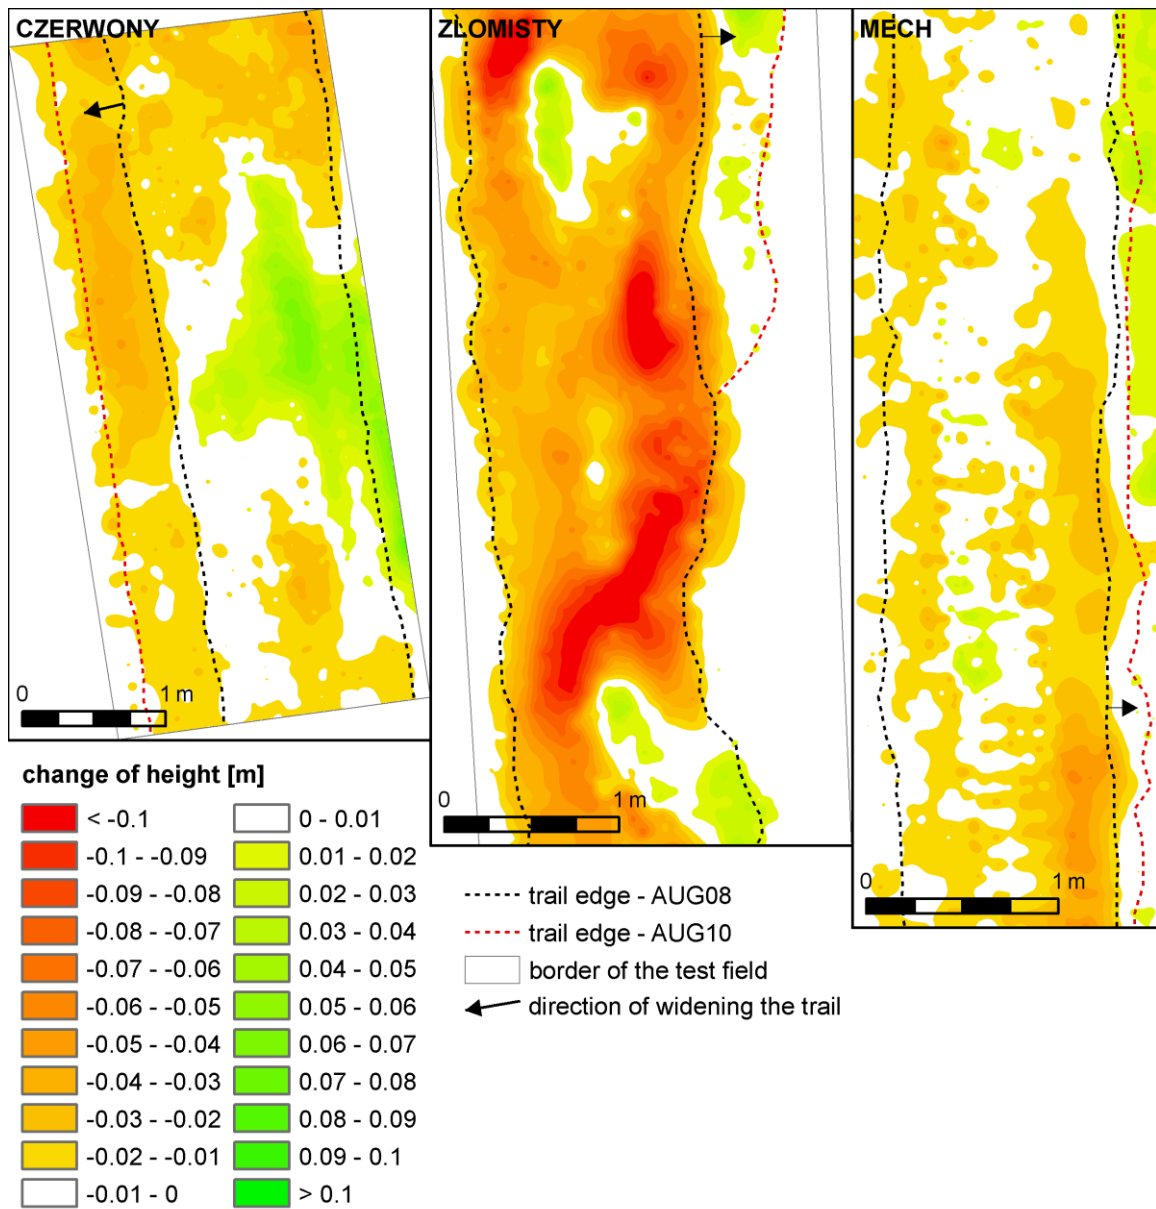
Figure A-3. DEMs of Differences (DODs) showing the spatial distribution of surface transformations between August/September 2008 and August/September 2010 – test fields located in the PLP – Part I.

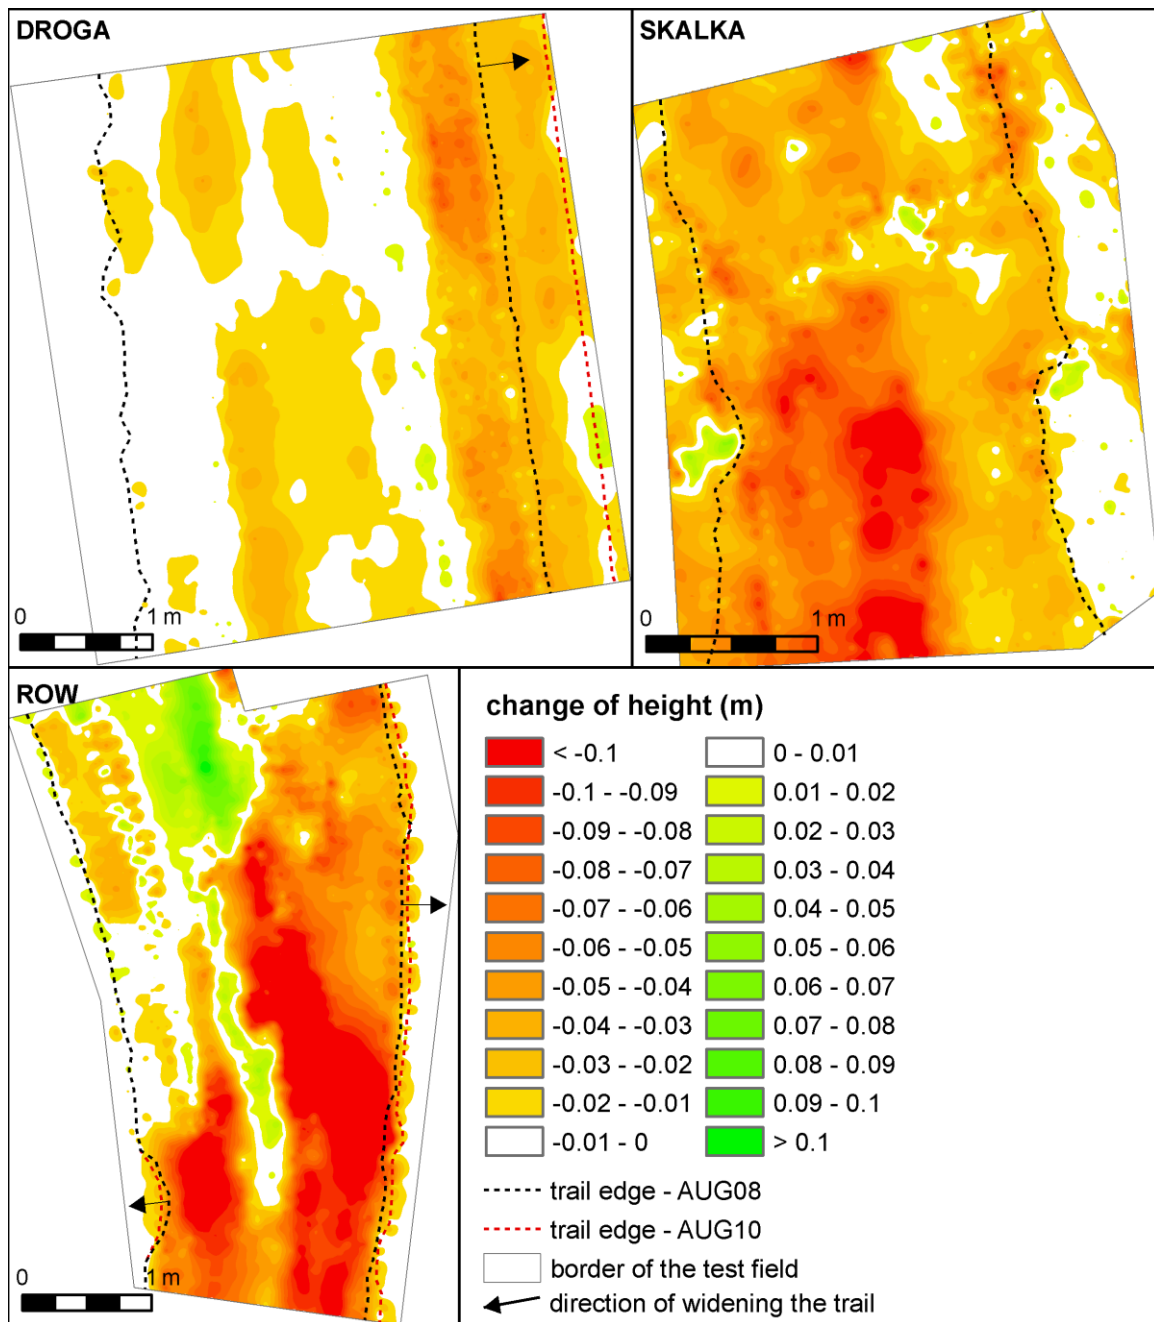
Figure A-4. DEMs of Differences (DODs) showing the spatial distribution of surface transformations between August/September 2008 and August/September 2010 – test fields located in the PLP – Part II.
